# Freelance Appraisals Inc.

Appraisal Documentation

Cranborne Holdings Inc.

2008 Caterham Super 7 GSX-R 1400

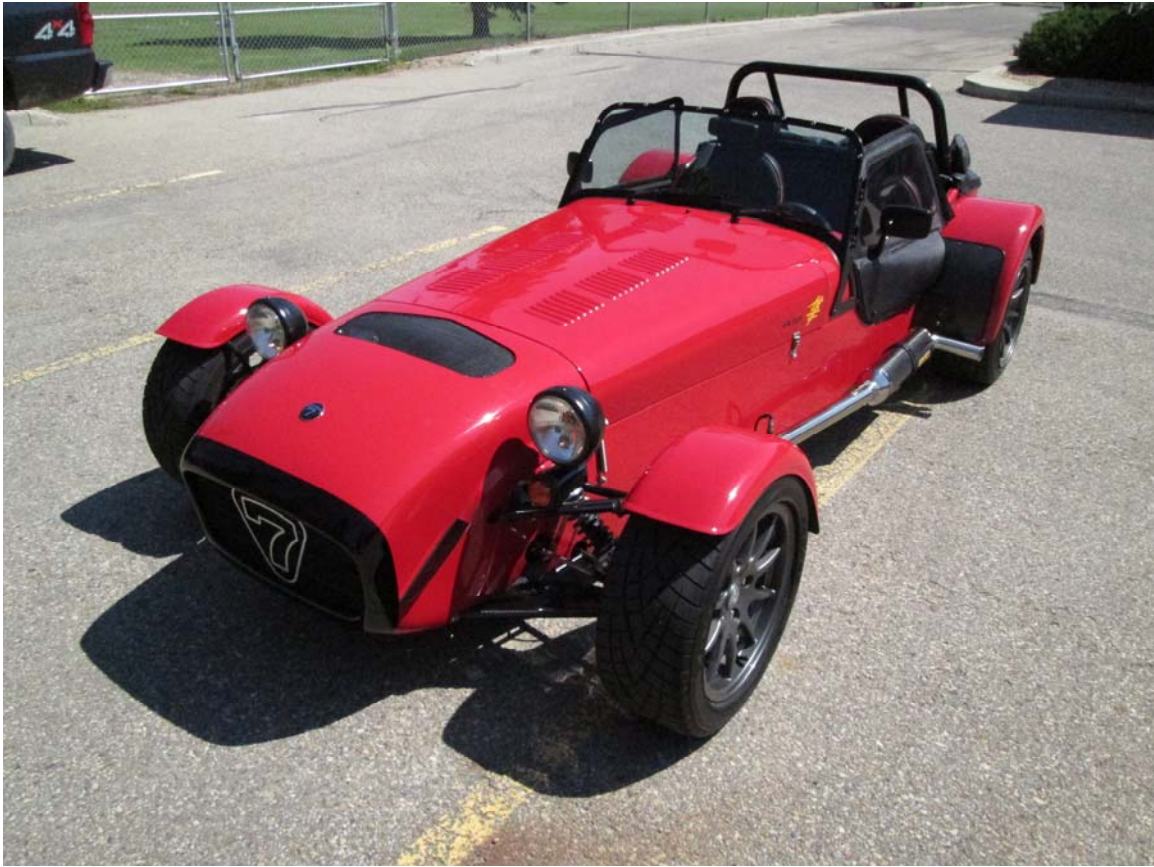
Year: 2008

Make: Caterham

Model: Super 7 GSX-R 1400

Style: Two - door convertible

Vehicle Identification Number: 2BG81023371008017 is taken from the engine bay  
British Columbia Assigned Vehicle VIN plate

Odometer Reading: 15,172 kilometers showing.

Body Colour: Caterham Red

Additional Information: Vehicles weighs 1,190 pounds with shattering performance of 0-100km 2.9 seconds.

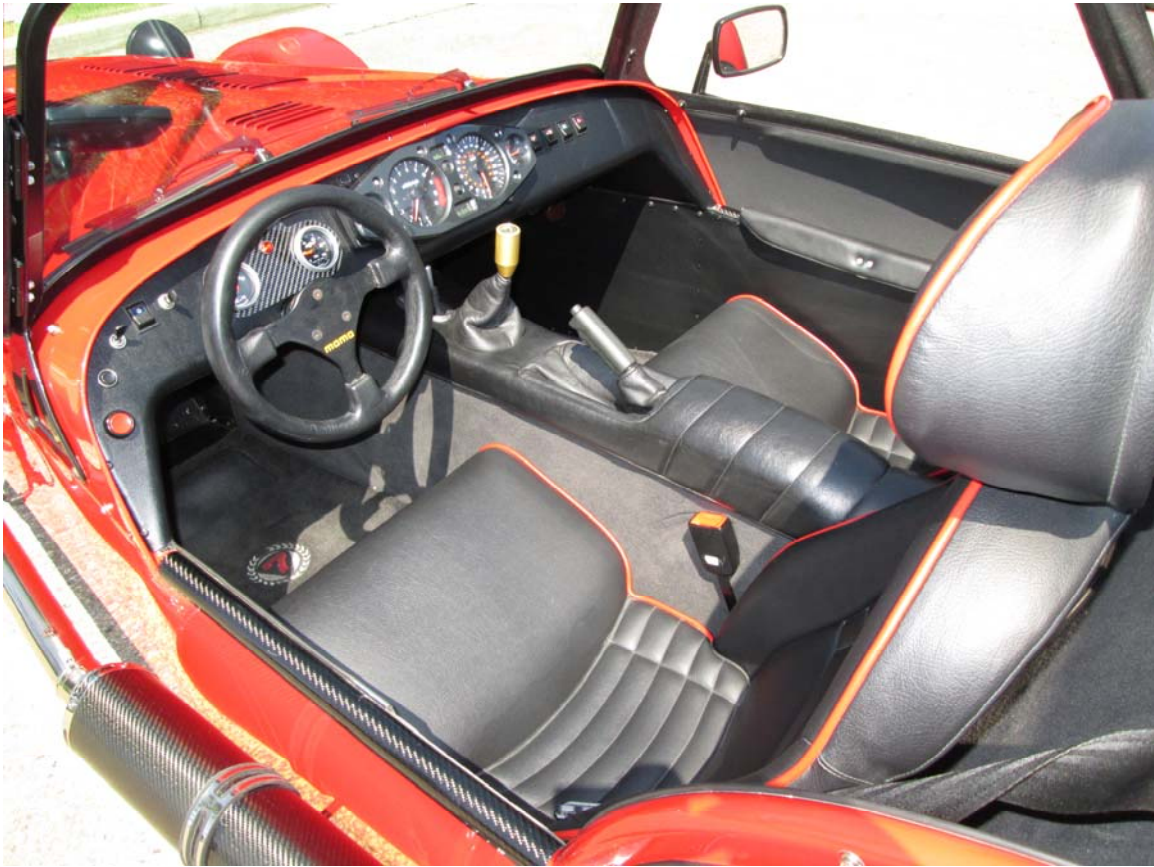
Electrical System: All system components are in excellent working condition

Body Check: We performed a thorough visual inspection of the vehicles fiberglass and aluminum body panel. See page 08 for panel inspection results.

Additional Information: AP Racing 4 piston brake calipers with uprated and increased dimension ventilated discs with stainless hoses, High volume alloy twin fan radiator, Stainless adjustable camber top-joints, Adjustable rear sway-bar, Watts linkage, adjustable black leather competition style bucket seats with red piping, carbon fiber dash face plate, speedometer with digital odometer, volts, oil psi, water temp, fuel gauge and tachometer, Carbon fiber lower front wishbone aero foils, polished carbon/stainless Arrow exhaust, black pack, lowered 5 inch light weight head lamps, Aero fuel cap, carbon fiber nose-cone whiskers, high down force & vented nose cone, side-screen armrests, 7 logo hood bag, Momo quick release steering wheel, 12V power socket, master on/off power switch, half-doors, wind deflectors, starter button, 7 logo-mats, storage bin, hi visibility LED brake light and carbon license plate holder.

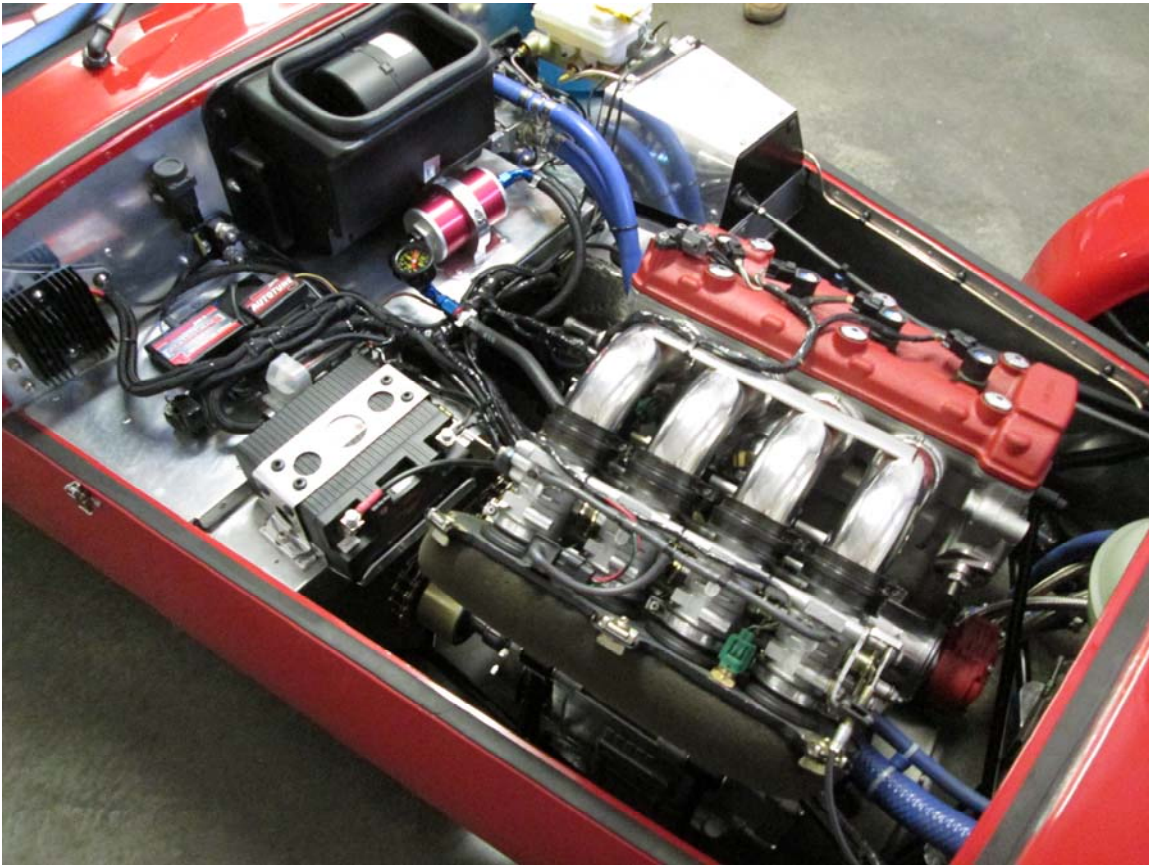
Engine: Suzuki Hayabusa GSX-R 1400

Transmission: 6-speed sequential

Axle Ratio: 3.14:1

The car started well and ran well with no unusual noises from any of the mechanical components. The car was moved but not test driven as part of the appraisal inspection.

Tires Front: Toyo Proxes R1R. ZR. Front: 195/50-15 - Rear: 225/45-15

Wheels: Light weight multi-spoke Motosport: Front 15 x 7, Rear 15 x 9

Additional Information: The engine and transmission have just been upgraded by a well-known Pro Hayabusa Race Engine builder, 1,600 kilometers ago. See page 8 for full list of driveline & performance upgrades.
