Freelance Appraisals Inc.

Appraisal Documentation

Terry Johns

2014 Homebuilt S3 Supersport

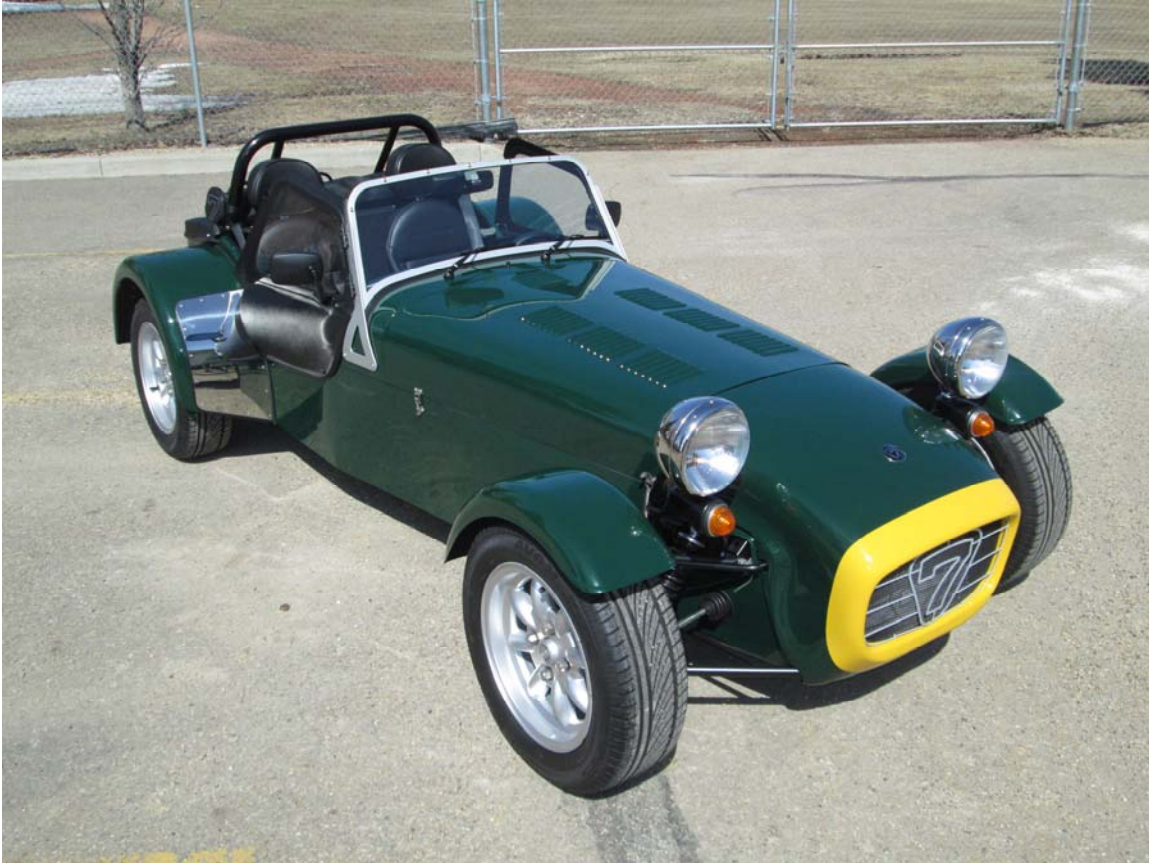
Vehicle Identification Number: 2ATE04083EU110357 is taken from the engine bay
Alberta Assigned Vehicle VIN plate

Odometer Reading: 032.0 miles showing.

Body Colour: British Racing Green

Additional Information: The assembly was completed in April 2014.

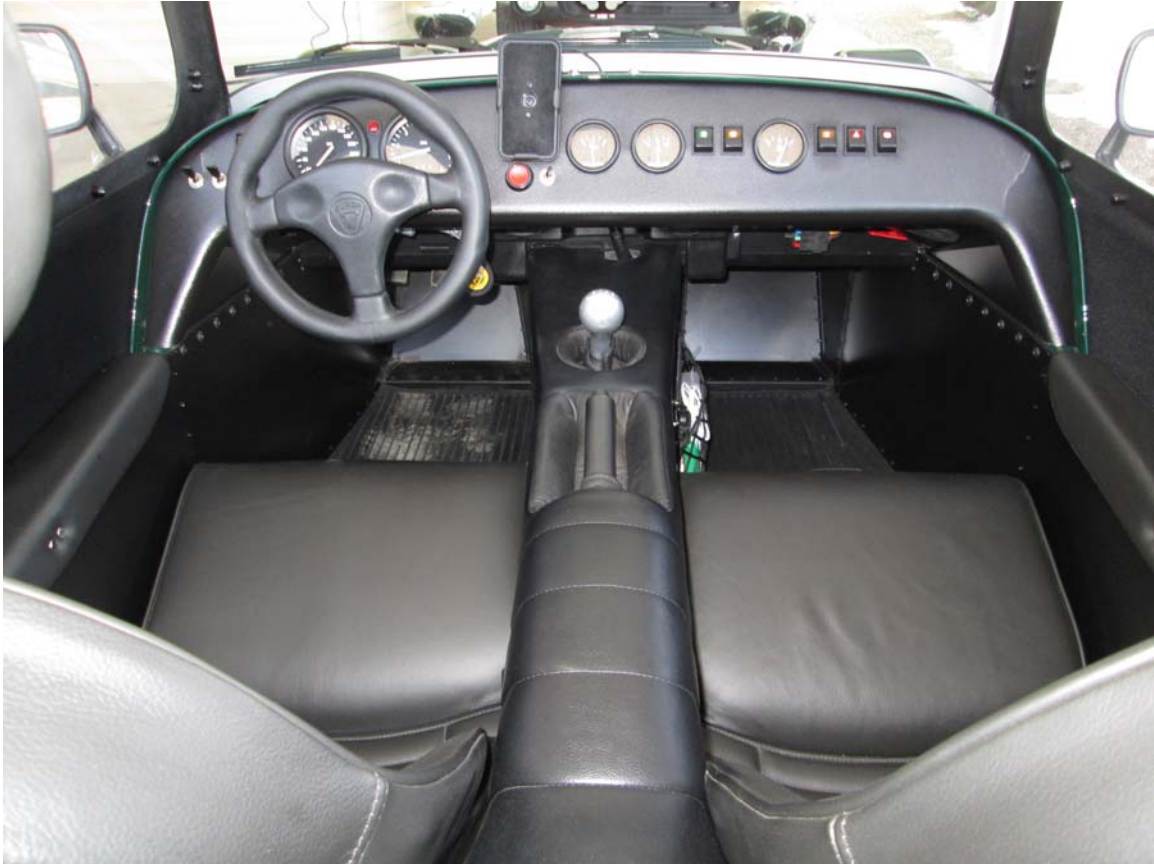
Electrical System: All system components are in excellent working condition

Body Check: We performed a thorough visual inspection of the vehicles fiberglass and aluminum body panel. See page 08 for panel inspection results.

Additional Information: Super 7 badges, Super 7 grill, Momo Super 7 quick release steering wheel, fresh air heat, FIA roll bar, leather bucket seats, full harness seat belts, full gauge package, immobilizer, full carpet & trim package, tools, tire jack, soft top, removable side screens, windshield bag, full tonneau and boot tonneau.

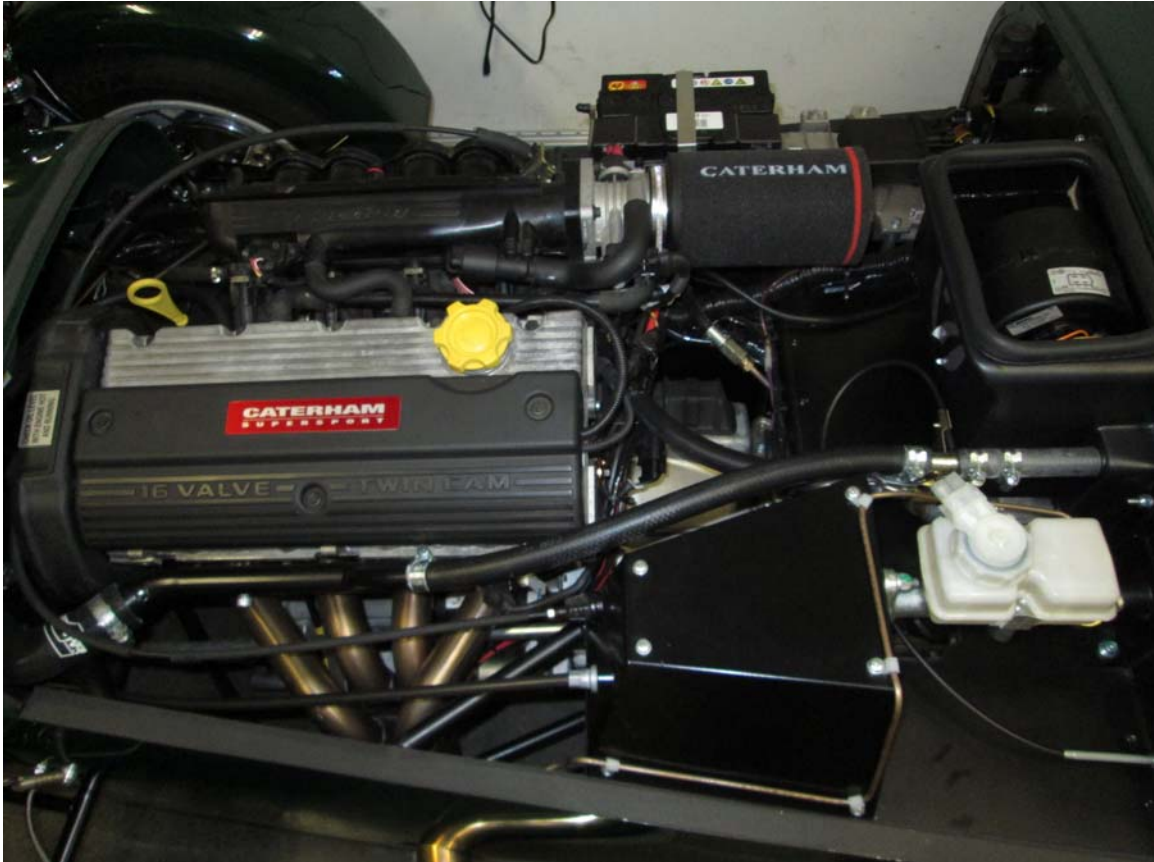
Engine: K-Series 4-cyl 135bhp 1.4L DOHC 16V

Transmission: Ford 5-speed manual with overdrive

Axle Ratio: 3.07:1

The car started well and ran well with no unusual noises from any of the mechanical components. The car was moved but not test driven as part of the appraisal inspection.

Additional Information: Digital fuel injection and ignition with feedback oxygen sensor, custom stainless steel exhaust & headers with built in catalyst muffler, dual circuit master cylinder with 4 wheel disc brakes, independent front suspension, Eibach linear springs, Bilstein shocks & sway bar, De Dion rear suspension, Bilstein shocks, rack & pinion steering rack with steering lock and BMW differential.
